CONNECTICUT COASTAL BASIN  
WEST HAVEN, CONNECTICUT  
**MALTBY LAKE DAM No. 1**  
**CT 00111**

PHASE I INSPECTION REPORT  
NATIONAL DAM INSPECTION PROGRAM

DEPARTMENT OF THE ARMY  
NEW ENGLAND DIVISION, CORPS OF ENGINEERS  
WALTHAM, MASS. 02154

AUGUST, 1979

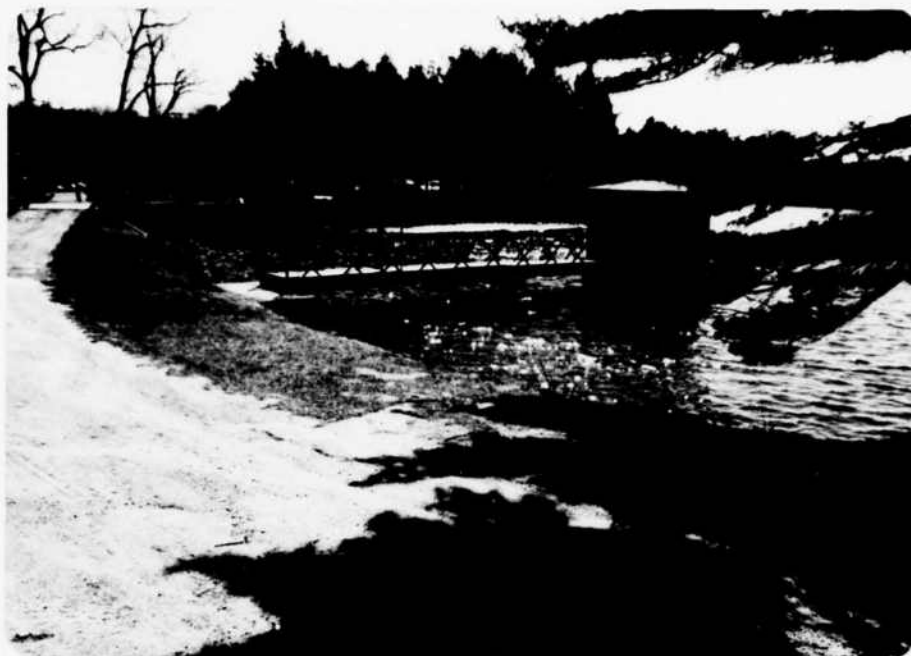
b. Dam Crest - The crest of the dam has a grass cover with a service road along its center line (Photo 1). The downstream portion of the crest is an 8 foot wide stone masonry section (Photo 2). No misalignment, depressions or cracks were observed along the dam crest. There was a low swale area on the natural ridge approximately 265 feet to the right of the spillway, which at elevation 136.4, would allow water from the reservoir to overflow 0.9 feet before the lake level reaches the top of the dam.

c. Appurtenant Structures - The concrete chamber of the upper gatehouse has no signs of visible cracks or spalling (Photo 1). No substantial rusting was observed on the metal service bridge.

PHOTO 1 - Upstream face of dam as seen from left abutment.  
Note intake structure and metal service bridge.

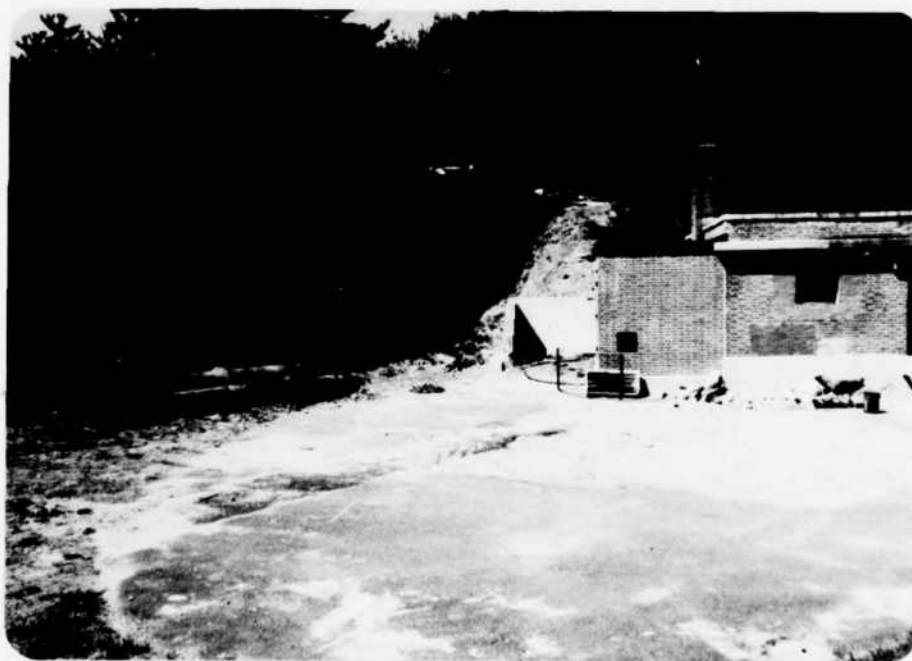
Downstream Slope - The downstream slope of the dam is the rubble masonry gravity section with a downstream face inclination of 1 horizontal to 3 vertical. The vertical upstream face of the masonry section was covered with a cement mortar coating and then had two coats of Portland cement grout brushed on when constructed. The downstream masonry face of the dam has some minor cracks along masonry joints with evidence of lime efflorescence (Photo 2). Some vines were observed on the lower portion of the slope. There are areas of runoff erosion along the toe of the left abutment where there is no erosion protection (Photo 2). The downstream slope of the earth embankment to the right of the spillway is steep and covered with wood chips for erosion protection (Photo 3). It was not apparent whether this area was a portion of the dam, and it showed no signs of erosion or instability.

PHOTO 2 - Left abutment and downstream face of dam.  
Note efflorescence from stone block masonry.

7. Erosion of the downstream face of the left abutment should be repaired, and the appropriate measures taken to prevent further erosion.

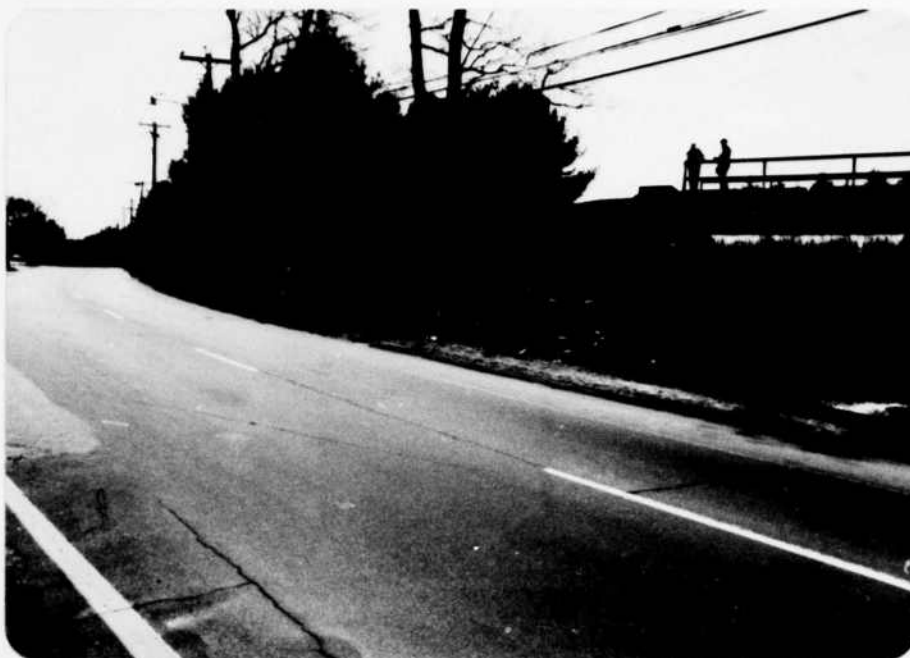
Spillway - The 21.5 foot long spillway is a stone masonry broad-crested rectangular weir with 4 feet of freeboard between its crest and the top of the dam. The spillway is spanned by a bridge which has a 2.8 foot high clearance from the top of the weir (Photo 3). The spillway is generally in good condition. Some minor deterioration was observed on the downstream wingwalls. The dam operator said there are several seepage spots on the spillway face which can be seen during the dry season. Some leakage at the spillway base was noted also by maintenance personnel in May, 1964 according to existing correspondence. During a preliminary inspection performed on April 17, 1979, at a time when water was not flowing over the spillway, we observed seepage in two

places immediately adjacent downstream of the weir. Seepage was emanating from the right training wall at the bedrock interface, and on the left training wall from the mortar joints between two stone blocks. Seepage flow observed was minor, but steady.

PHOTO 3 - Right abutment and spillway crest.

2. The seepage from the spillway face and spillway channel walls should be monitored periodically for any change in the condition.
3. Vegetation, such as vines, at the downstream slope of the masonry section should be removed to avoid deterioration of the masonry.
4. Surface erosion along the downstream face of the left abutment should be repaired to prevent further, more serious erosion.
5. With the low level outlet pipes gated on the downstream side of the dam, the conduits through the dam are under constant head. This situation is not desirable, and in the future should repair or redesign of the hydraulic facilities take place, consideration should be given to the installation of gates on the upstream side of the dam.

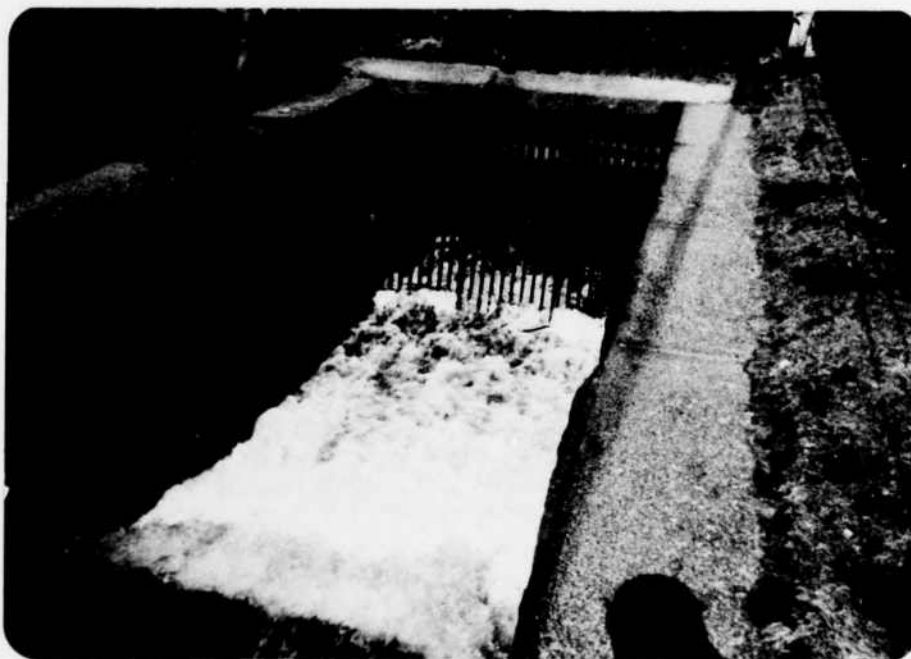
The spillway discharge channel is a 10 foot wide and 3 foot deep open trough with concrete stone coping walls, and leads to a concrete arch culvert under Connecticut Route 34 immediately downstream. Some cracking and spalling of the concrete was observed at the left wall of the channel (Photo 4).

PHOTO 4 - Entrance to culvert under road located near toe of dam. Note cracking and spalling of sides of concrete spillway channel.

1. The deteriorated masonry and concrete surfaces of the spillway and the spillway discharge channel should be repaired to prevent their further deterioration.

4. The cracking and spalling of the concrete and masonry of the gravity section of the dam, the downstream face of the spillway and the spillway diversion channel walls should be repaired.
